NYC DEP Corrosion Control Research

Expert Panel Workshop

Final Report

New York City Department of Environmental Protection

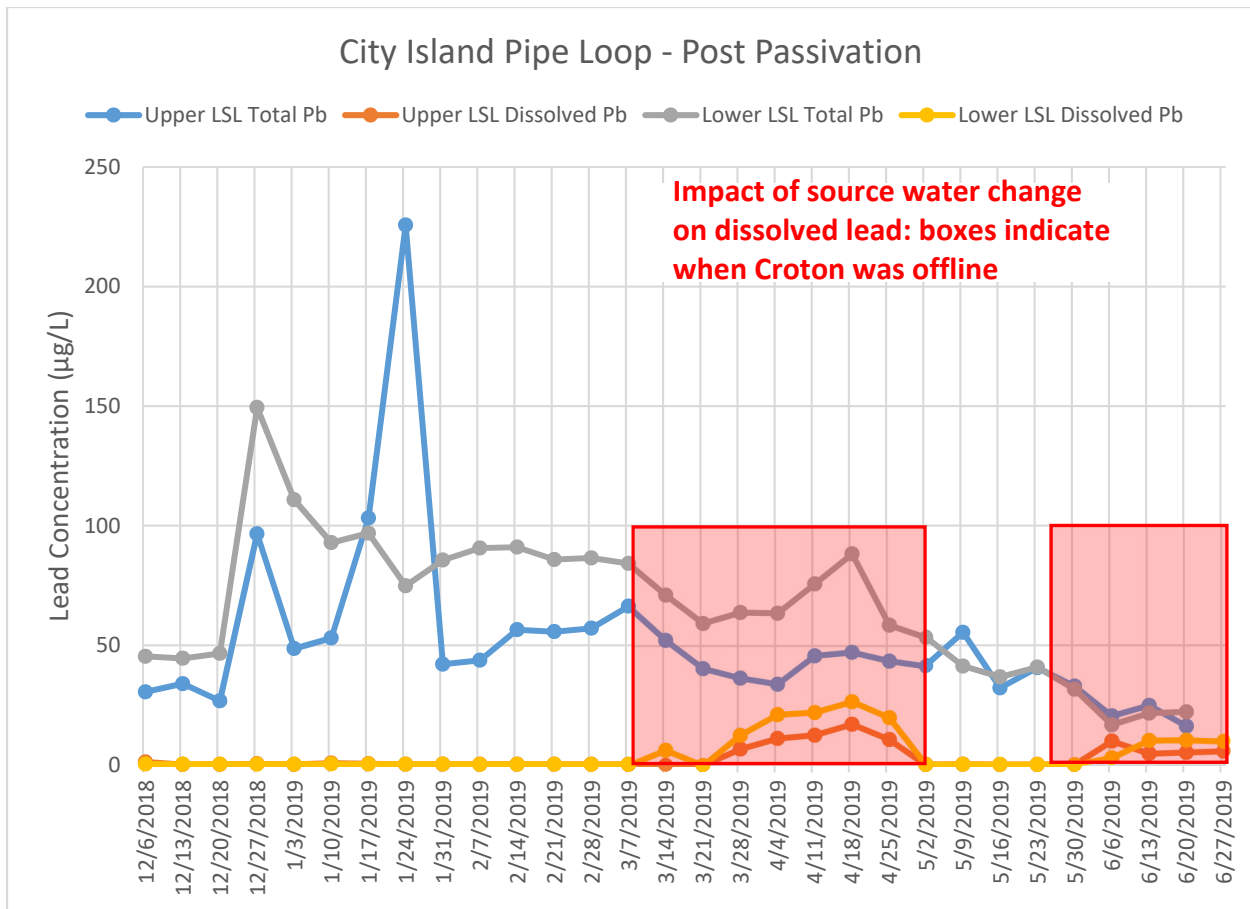
Sampling of pipe loop

A pipe loop, made from ~ 20 foot of LSL discovered and harvested from a DEP yard in the Bronx, was installed at the Bureau of Wastewater Treatment (BWT) pump station located at 191 East Schofield Street, City Island, Bronx, NY 10464, as two (2) 7.5 foot pipe loops. Solenoid valves with timers were installed to routinely run fresh water through the LSL, simulating the daily use of an occupied home. Staff sample the water from the pipe loop to determine the effect of the increased orthophosphate dose. Over time, depending on the operation of the Croton Filtration Plant, both Croton and Catskill/Delaware water can be studied, as can be seen in the graph below. When the Croton supply is turned off, the dissolved lead in the samples collected from the loop increases. The graph also shows improvement with passivation/stabilization, with total lead levels decreasing over time.

The expert panel expressed concern that the pipe used for the loop did not come from a residence or a building with regular water use, and they thought the scale might not reflect conditions seen when water regularly flows through a pipe. In response to these concerns, flushing of the loop has been increased from once to twice a day. Additionally, DEP has identified additional lead service lines from New York City Housing Authority (NYCHA) residences that are being used to construct more pipe loops. A control loop has been set up at the Distribution Laboratory, as this location never receives Croton water and will not have any changes to the PO₄ dose. DEP also has plans to install another loop at the BWT pump station on City Island. Furthermore, DEP is investigating using some of the pipe for a coupon study, which would be carried out using the protocol outlined in a Cornwell paper to be published in the October 2019 issue of the *Journal of the American Water Works Association*.

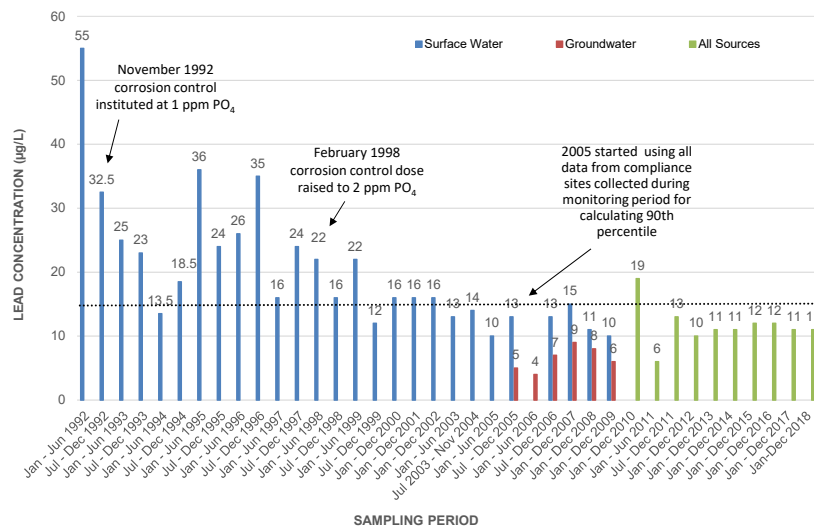
At-the-Tap 90th Percentile Lead Concentrations

The Groundwater System was acquired by DEP in 1997. Between 2005 and 2009 the 90th percentile concentration was calculated separately for the groundwater and surface water systems.

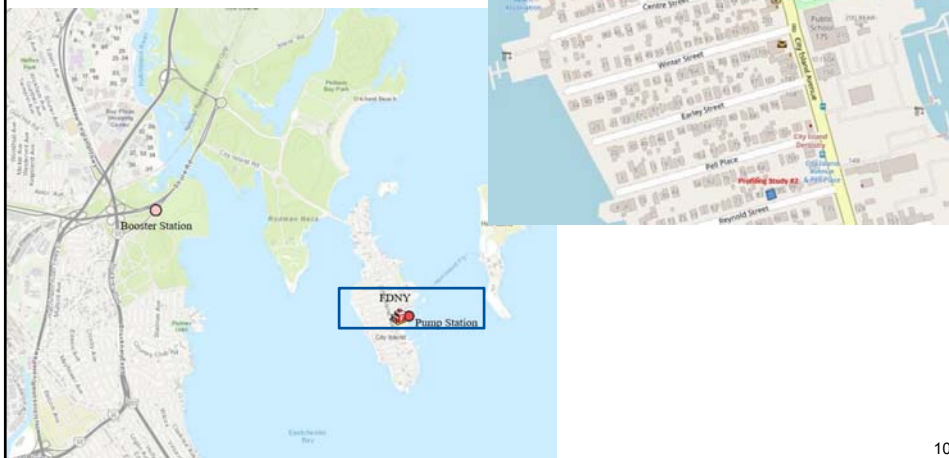
City Island:
 oPO_4 booster station and
monitoring locations

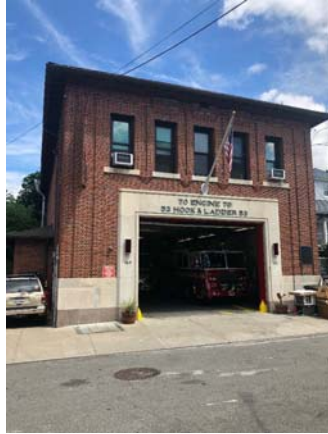
Optimizing Corrosion Control Pilot Study

Continuous oPO_4 analyzer:

- Installed at FDNY E70/L53
- Data can be viewed remotely

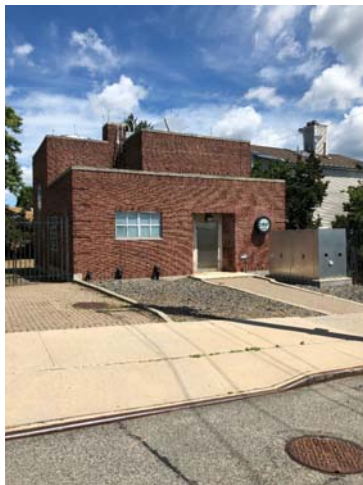
Optimizing Corrosion Control Pilot Study

Pipe Loops:

- Two ~7 ft lengths of LSL harvested from NYC distribution system were installed inside a DEP-BWT pump station
- Pipes conditioned with fresh water daily
- Sampling commenced on 9/20/2018, currently weekly

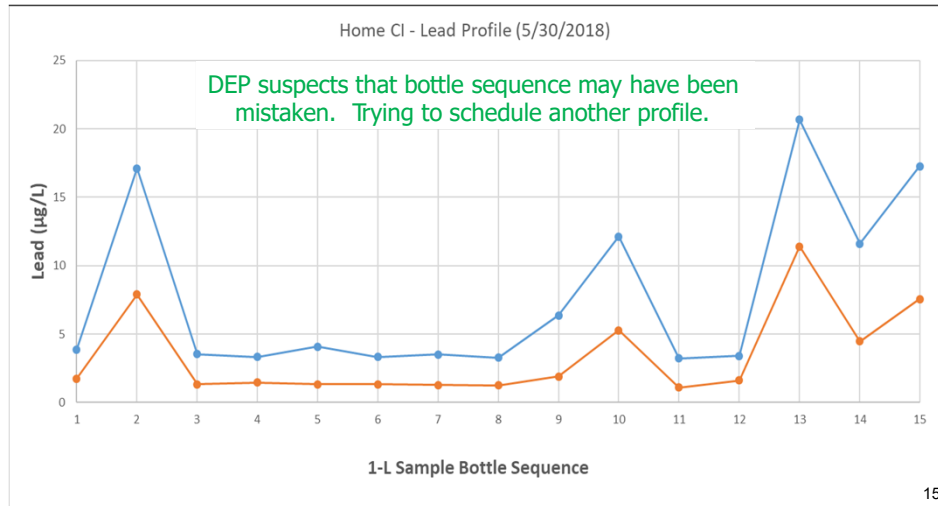
Profile Sampling of Home 1 CI

- ¾" diameter LSL with ¾" diameter brass interior piping
- First lead profile completed on May 30, 2018

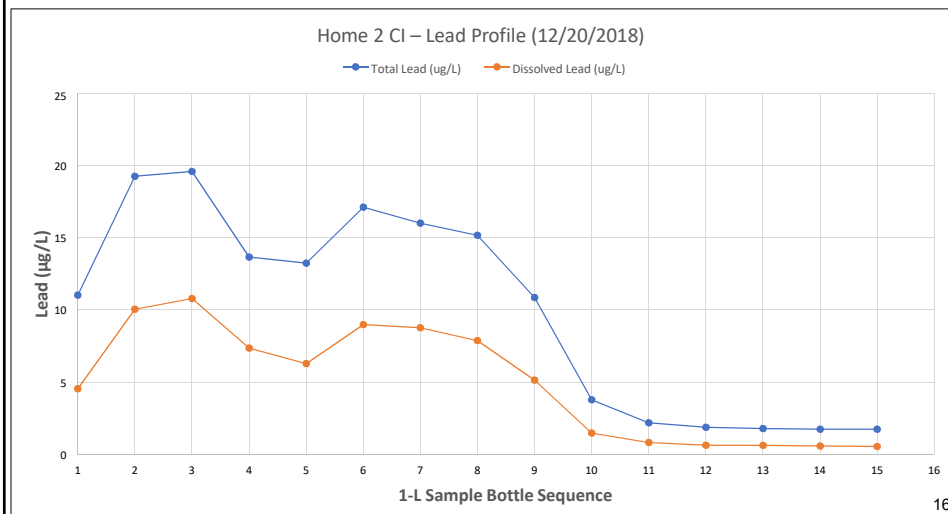
Profile Sampling of Home 2 CI

- ¾" diameter LSL with ¾" diameter copper interior piping
- First lead profile completed on December 20, 2018

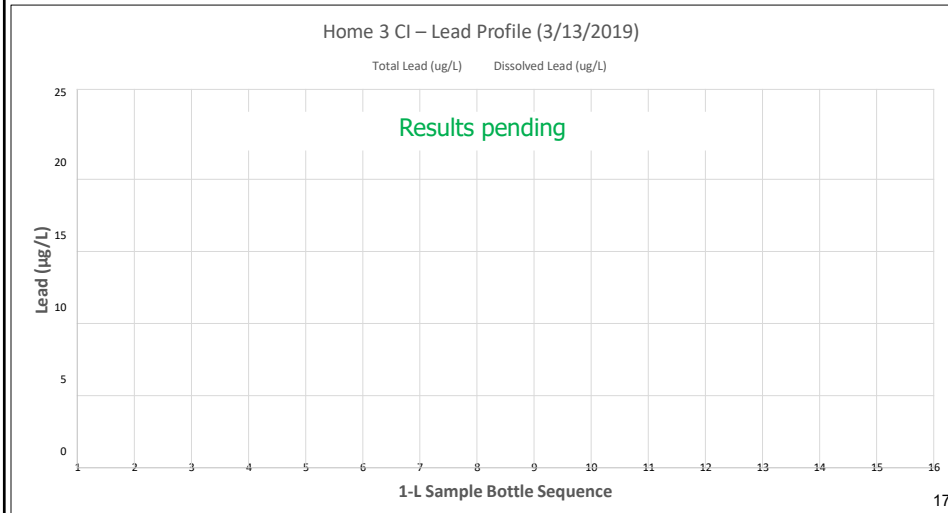
Profile Sampling of Home 3 CI

- 1/4" diameter copper SL with copper interior piping
- First lead profile completed on March 13, 2019

→ "Control Group"

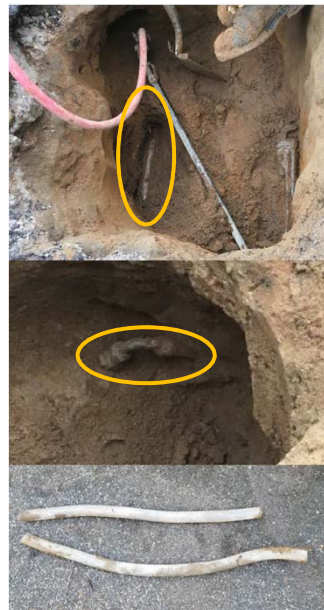
Lead Pipe Scale Analysis

- In order to identify the the lead corrosion products that have formed over time, and understand the solubility of lead and the potential for its release in different areas of the distribution system, six segments of lead pipe were harvested from the NYC distribution system
 - Two from City work yards located in the Bronx without constant water use
 - Two from single family homes located in Queens that were supplied groundwater in the past
 - Two from single family homes in Queens that were only supplied surface water

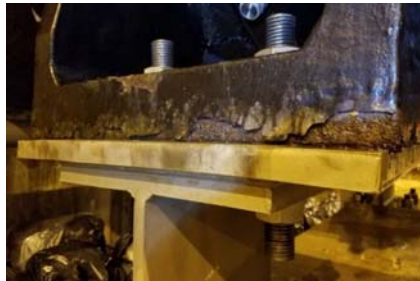
Galvanic Corrosion

Carbon steel cradle on top of stainless steel base

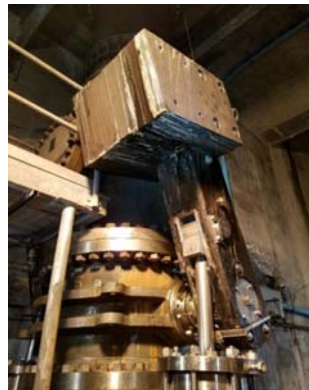
Carbon steel counterweight and stainless steel arm

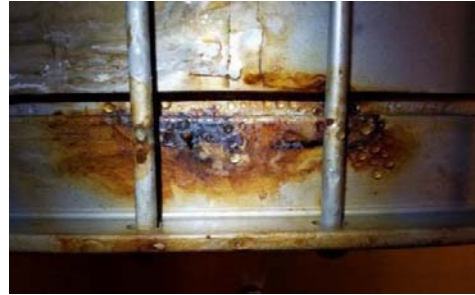
Handling Suspected MIC

- Camera inspection around sleeve coupling location of laterals
- Possible mitigation include:
 - Disinfection – shock treatment
 - Mechanical Removal

- ❖ Recommendation for mitigation cannot be made until extent of damage to stainless steel internals is known.

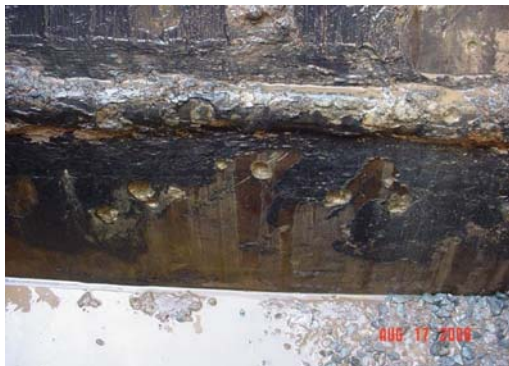
Water infrastructures are susceptible to stray current corrosion that originate from nearby unprotected electrical utilities underground

- Damage from stray current corrosion is different from natural corrosion because it is caused by an external electrical current and is independent of such environmental factors including oxygen concentration, chloride or pH
- Stray current corrosion damage is localized to where the current leaves the surface of the pipe

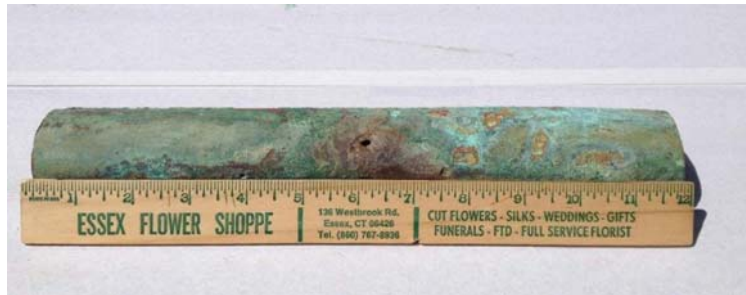
Water Service Lines

DEP issued an investigation in response to multiple copper service water piping corrosion failures

- The results of the field studies shows evidence that the likely cause of failures of the 1-in copper service lines was due to stray DC current caused by a buried, Verizon-owned, lead-sheathed communications cable
- Copper service water piping acts as the anode. Whereas electrons migrate from the surface of the copper line, through the soil, and to the Verizon lead-sheathed 48 Volt cable service that acts as the cathode
